KOJONUP WIND FARM

Shadow Flicker and Blade Glint Assessment

Report No.: 10557557-AUMEL-R-02, Rev. D

Date: 15 October 2025

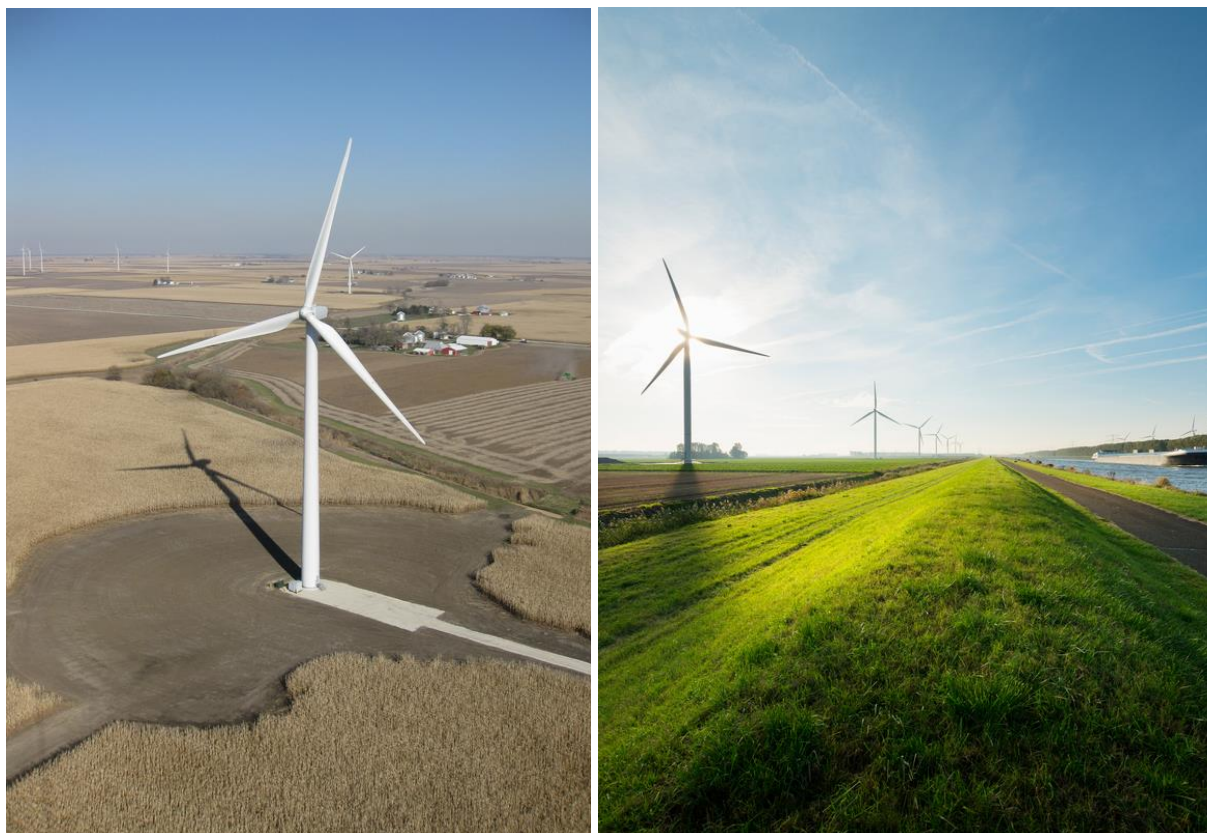
Figure 1 Examples of wind turbine shadows

Example photographs of wind turbines and associated shadows which have the potential to cause flicker are shown in Figure 1 below.

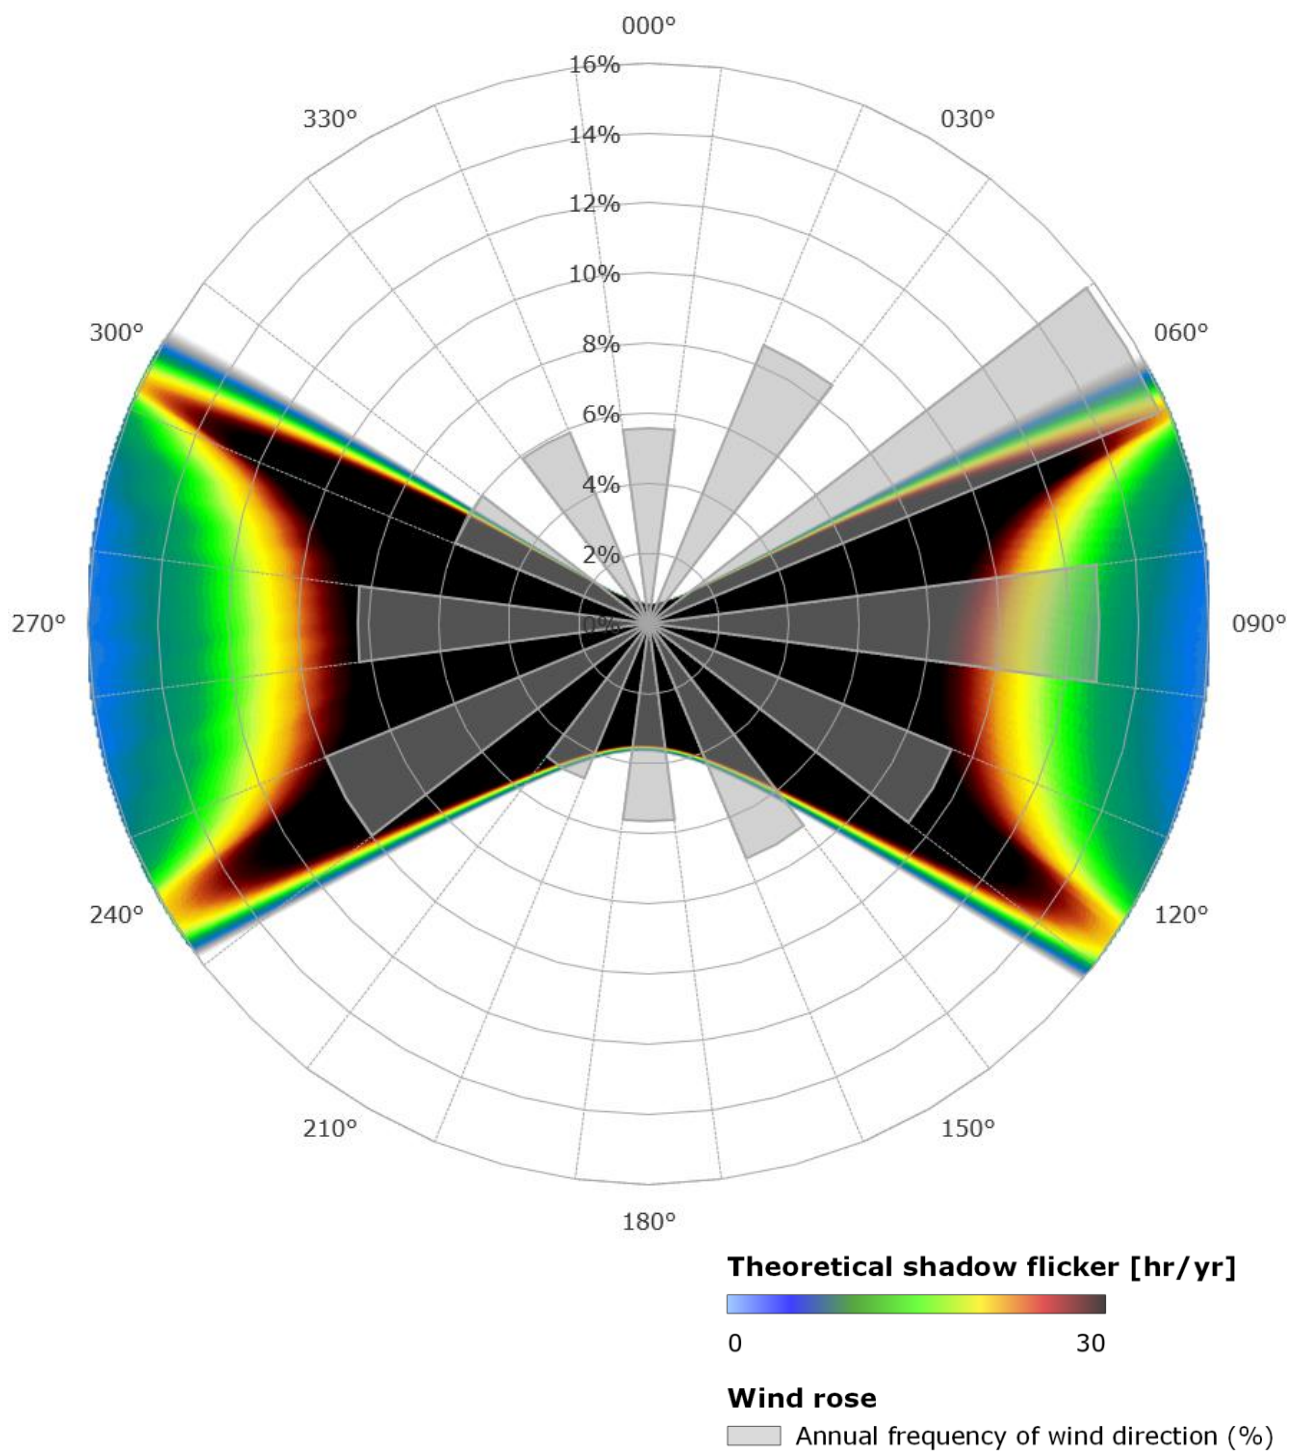
Figure 4 Indicative shadow flicker map and wind direction frequency distribution

To illustrate typical results, an indicative shadow flicker map for a turbine located in a flat area is shown in Figure 4. The geometry of the shadow flicker map can be characterised as a butterfly shape, with the four protruding lobes corresponding to slowing of solar north-south travel around the summer and winter solstices for morning and evening. The lobes to the north of the indicative turbine location result from the summer months and conversely the lobes to the south result from the winter months. The lobes to the west result from morning sun while the lobes to the east result from evening sun. When the sun is low in the sky, the length of shadows cast by the turbine increases, increasing the area around the turbine affected by shadow flicker.

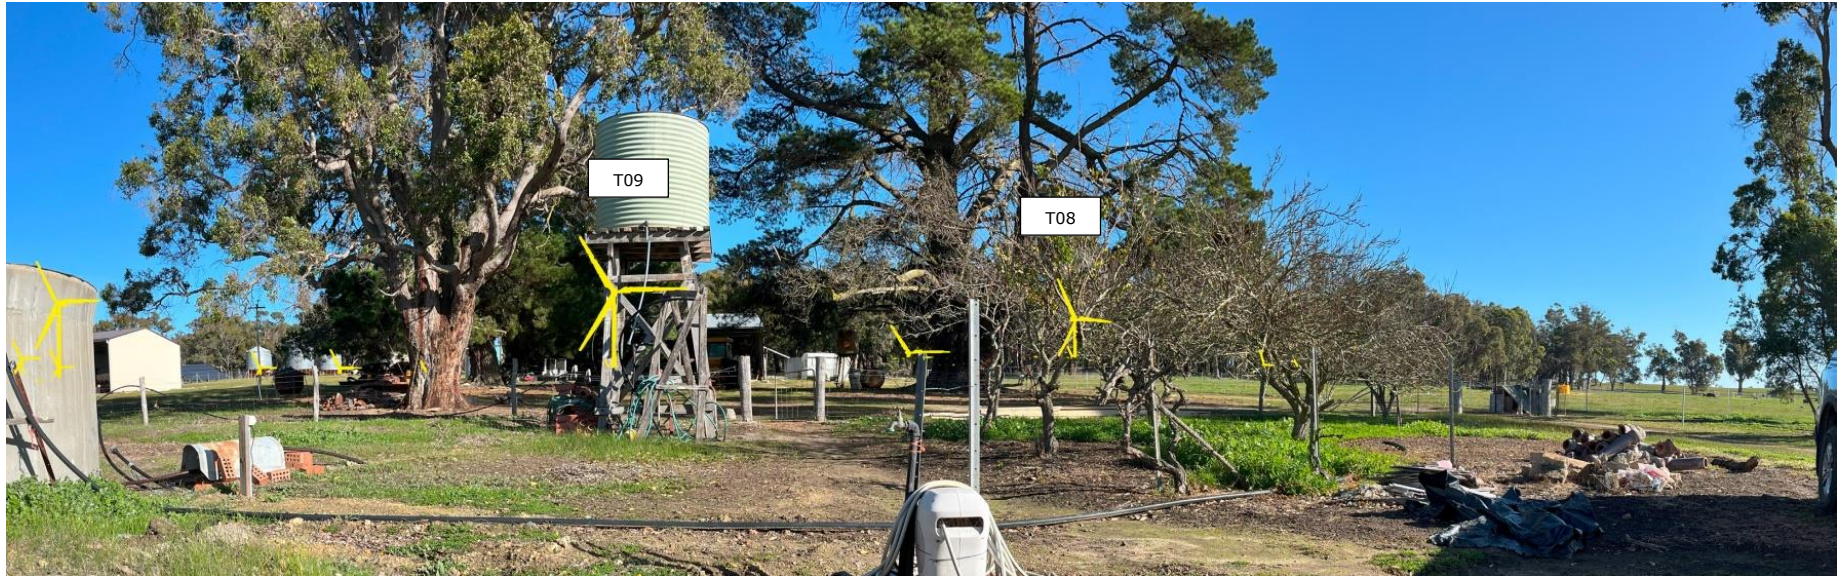
Figure 7 Photomontage taken near Dwelling 1 (view towards the West)

A photomontage for a viewpoint located near the northwest corner of the dwelling, with the view facing west, is presented in Figure 7 in Appendix A.

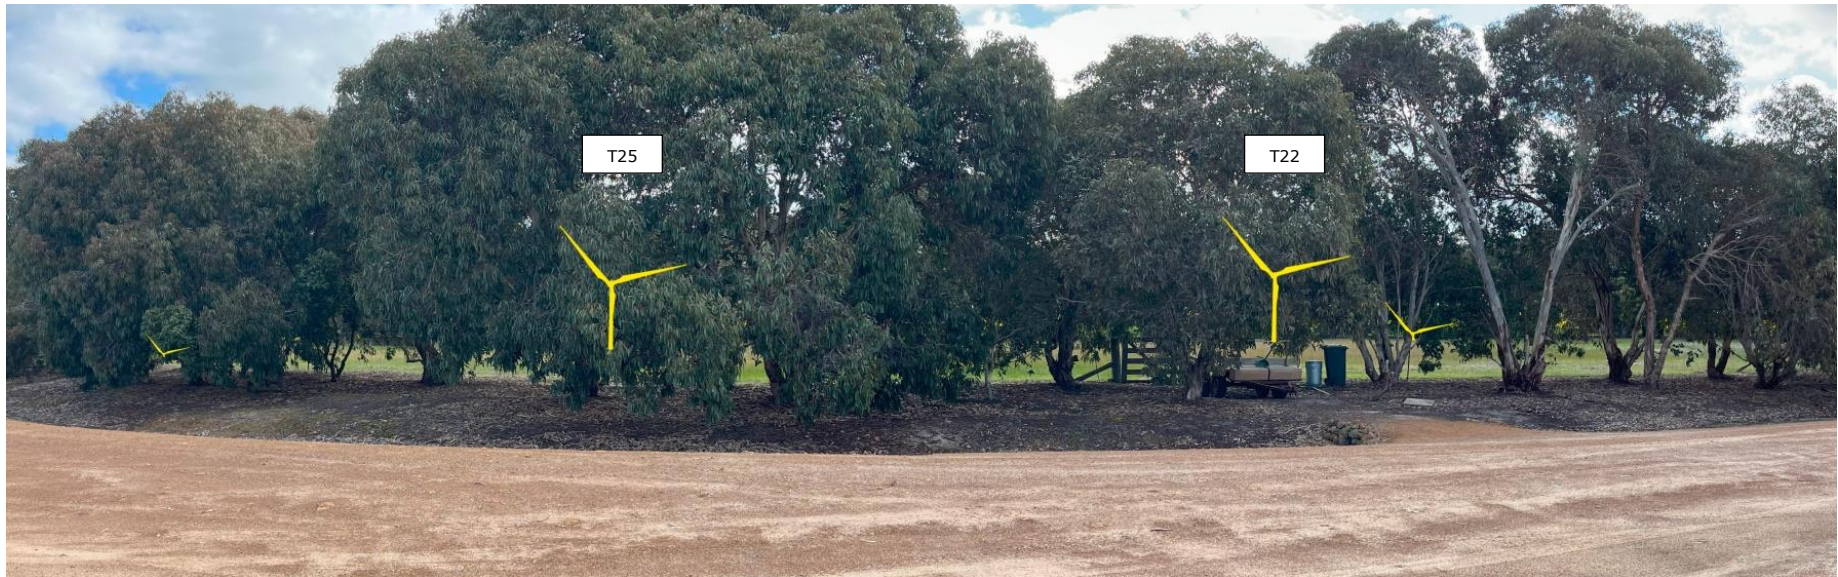
Figure 8 Photomontage taken near Dwelling 10 (view towards the West)

Photomontages for viewpoints located near the west and northwest and east sides of the dwelling, with the view facing west, north-northwest and northeast are presented in Figure 8, Figure 9, Figure 10 respectively in Appendix A.

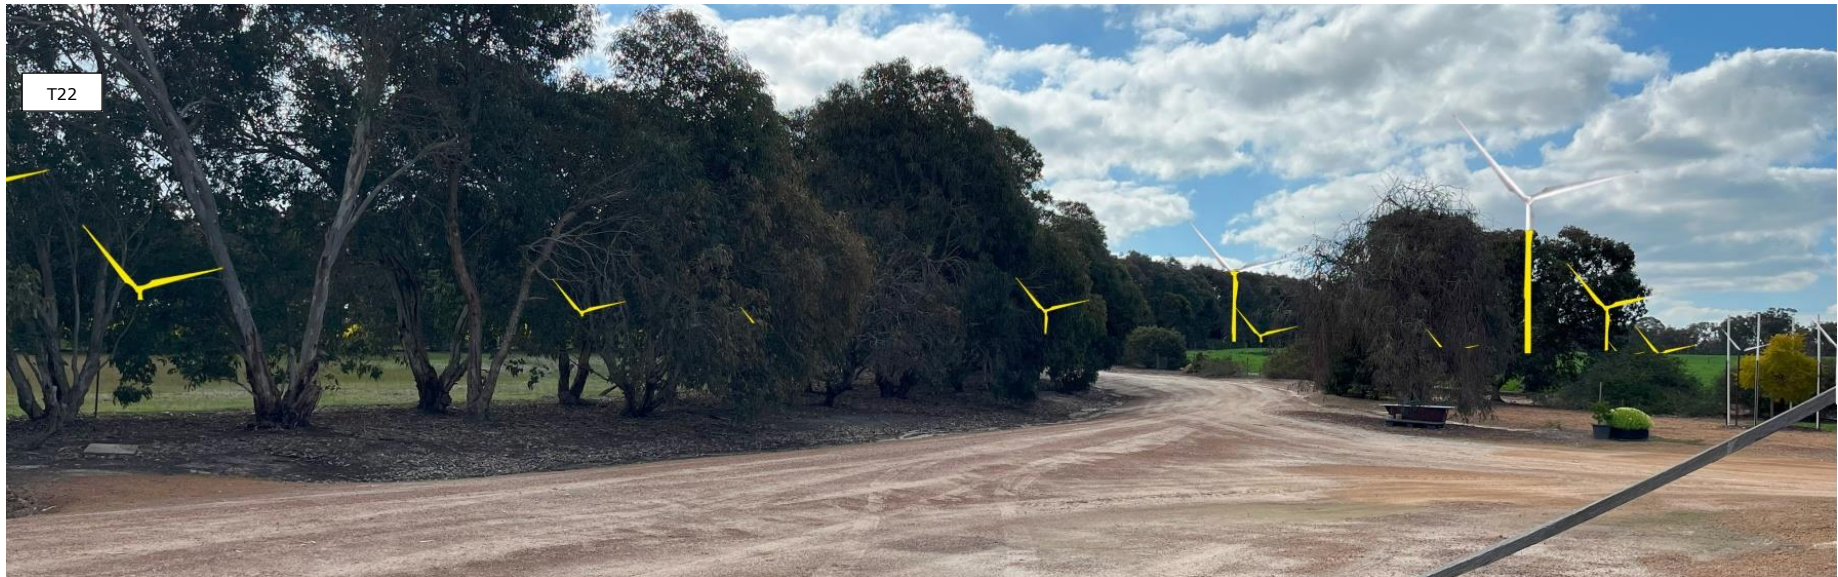
Figure 9 Photomontage taken near Dwelling 10 (view towards the North-northwest)

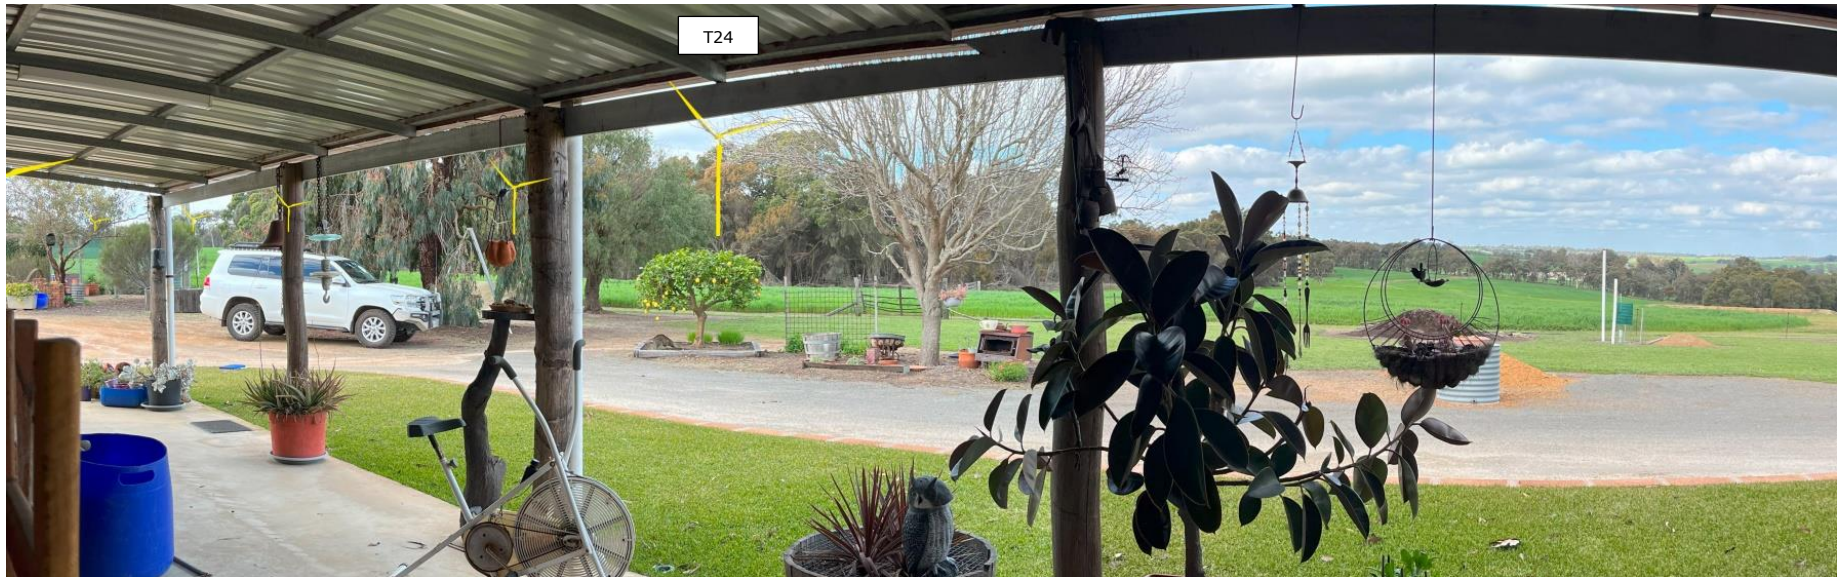
Figure 10 Photomontage taken near Dwelling 10 (view towards the Northeast)

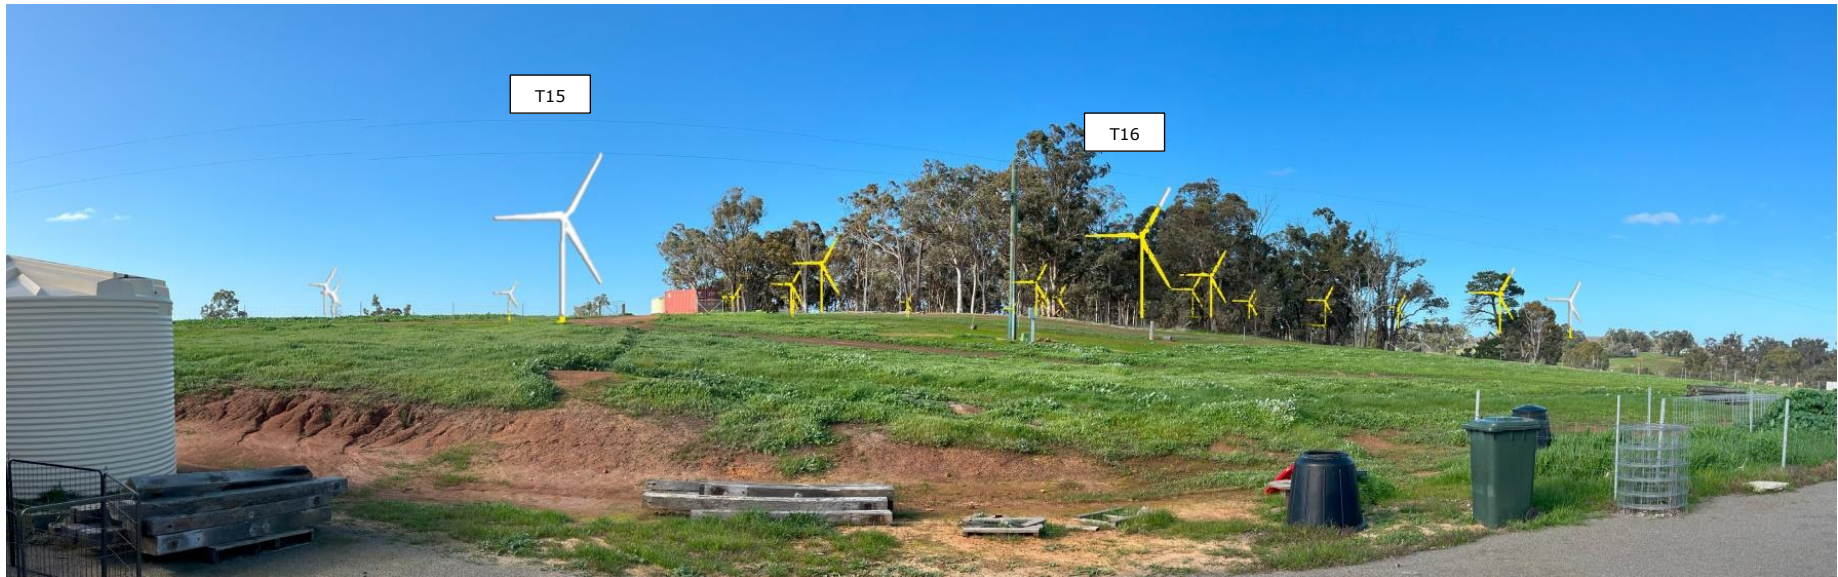
Figure 11 Photomontage taken near Dwelling 17 (view towards the East)

A photomontage for a viewpoint located near the east side of the dwelling, with the view facing east, is presented in Figure 11 in Appendix A.

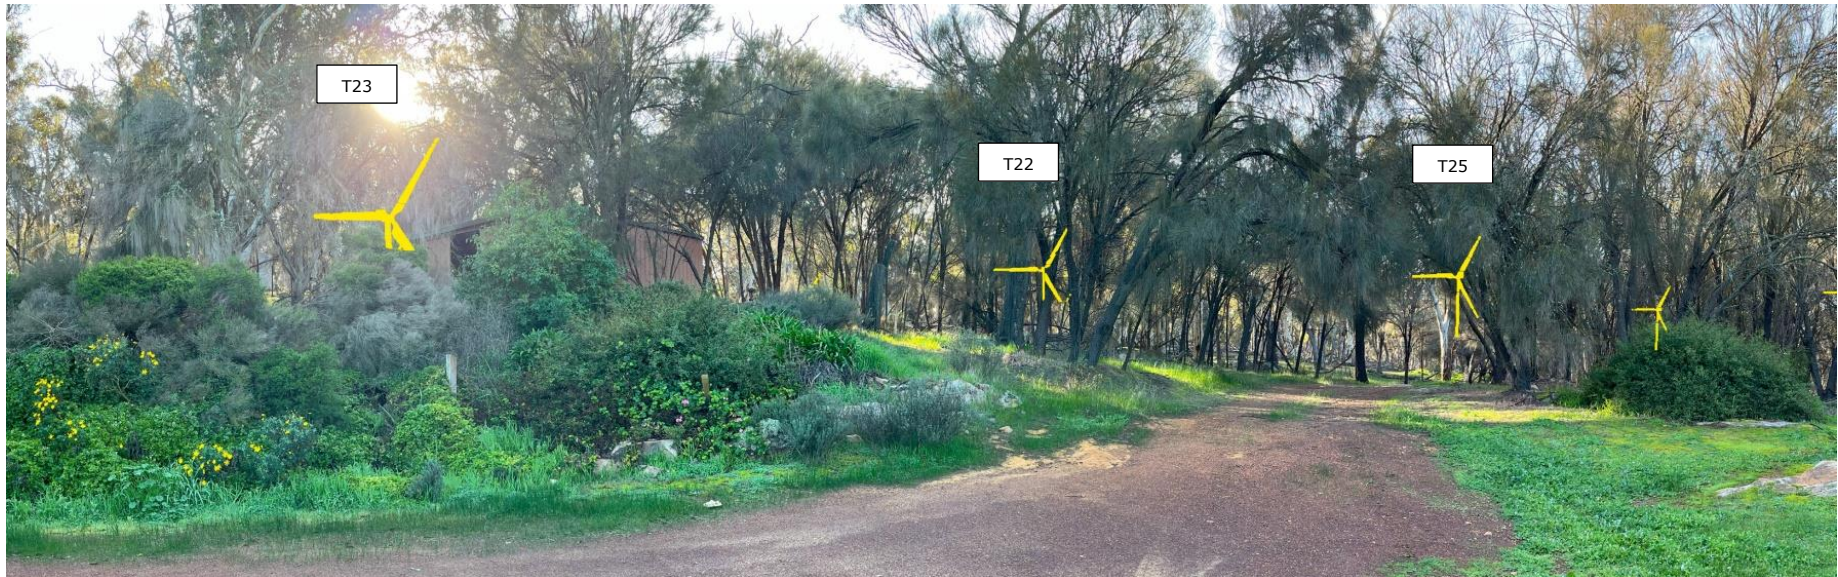
Figure 12 Photomontage taken near Dwelling 31 (view towards the East)

A photomontage for a viewpoint located near the east side of the dwelling, with the view facing east, is presented in Figure 12 in Appendix A.

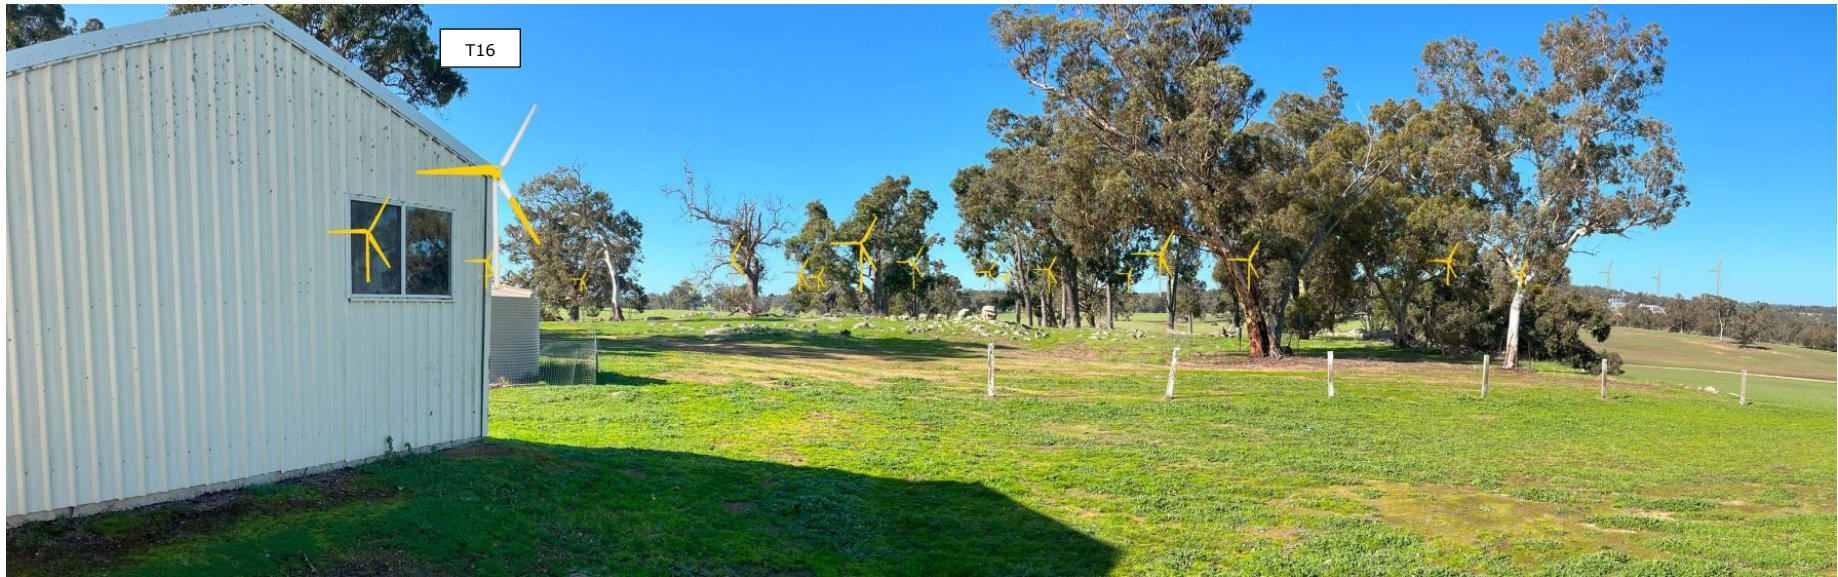
Figure 13 Photomontage taken near Dwelling 207 (view towards the East)

A photomontage for a viewpoint located near the east side of the dwelling, with the view facing east, is presented in Figure 13 in Appendix A.
